**DEPARTMENT OF TRANSPORTATION**

Quality Assurance and Source Inspection

Contract #: 04-0120F4Cty: SF/ALA Rte: 80 PM: 13.2/13.9File #: 69.28**WELDING INSPECTION REPORT****Resident Engineer:**Pursell, Gary**Address:** 333 Burma Road**City:** Oakland, CA 94607**Report No:** WIR-003131**Date Inspected:** 25-Jun-2008**Project Name:** SAS Superstructure**OSM Arrival Time:** 1400**Prime Contractor:** American Bridge/Fluor Enterprises, a JV**OSM Departure Time:** 2330**Contractor:** Zhenhua Port Machinery Company, Ltd (ZPMC), Changxing Island **Location:** Shanghai, China**CWI Name:** Sun Wei/Li Yanhua**CWI Present:** Yes No**Inspected CWI report:** Yes No N/A**Rod Oven in Use:** Yes No N/A**Electrode to specification:** Yes No N/A**Weld Procedures Followed:** Yes No N/A**Qualified Welders:** Yes No N/A**Verified Joint Fit-up:** Yes No N/A**Approved Drawings:** Yes No N/A**Approved WPS:** Yes No N/A**Delayed / Cancelled:** Yes No N/A**Bridge No:** 34-0006**Component:** OBG**Summary of Items Observed:**

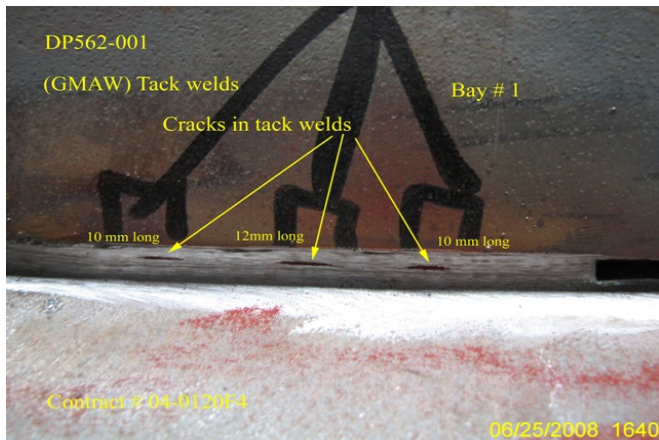
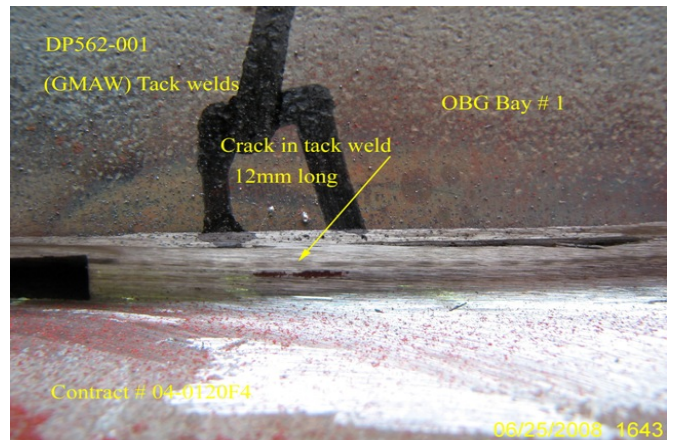
The QA Inspector inspected deck panel tack welds on DP562-001 at Gantry # 1 and observed 42 cracked tack welds which ZPMC personnel had found during a Magnetic Particle Inspection and had marked the U-rib numbering each indication found. The QA Inspector verified the length of the indications. ABF personnel Wang Zhen Hua and Lv Yun were also present to verify the cracks in the tack welds.
